# Replacement of safety windows on forest harvesting machines

## – results of a Nordic survey

Rolf Björheden, Skogforsk, Sweden, Carola Häggström, SLU, Sweden, Heikki Ovaskainen, Metsäteho, Finland, Mikael Fønhus, Skogkurs, Norway.

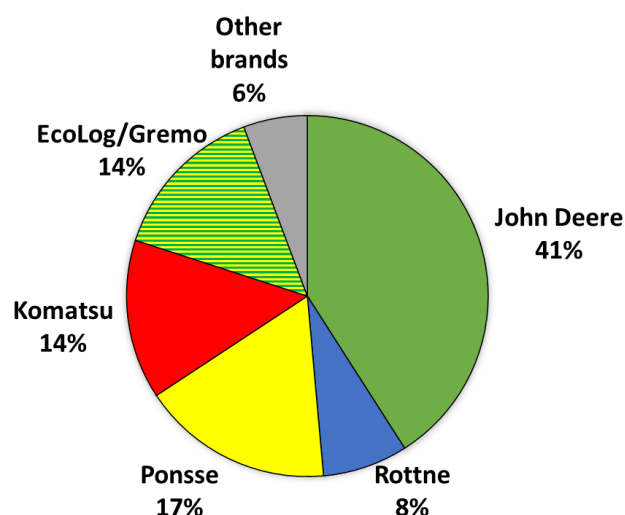
Figure 1. Five manufacturers represent 94 % of the window replacements reported in the survey.

The material includes 54 harvesters, 46 forwarders and one harwarder. Sixteen different brands are represented, but five manufacturers, John Deere, Komatsu, Rottne, Ponsse and Eco Log/Gremo together account for 94 % of the machines (Figure 1).

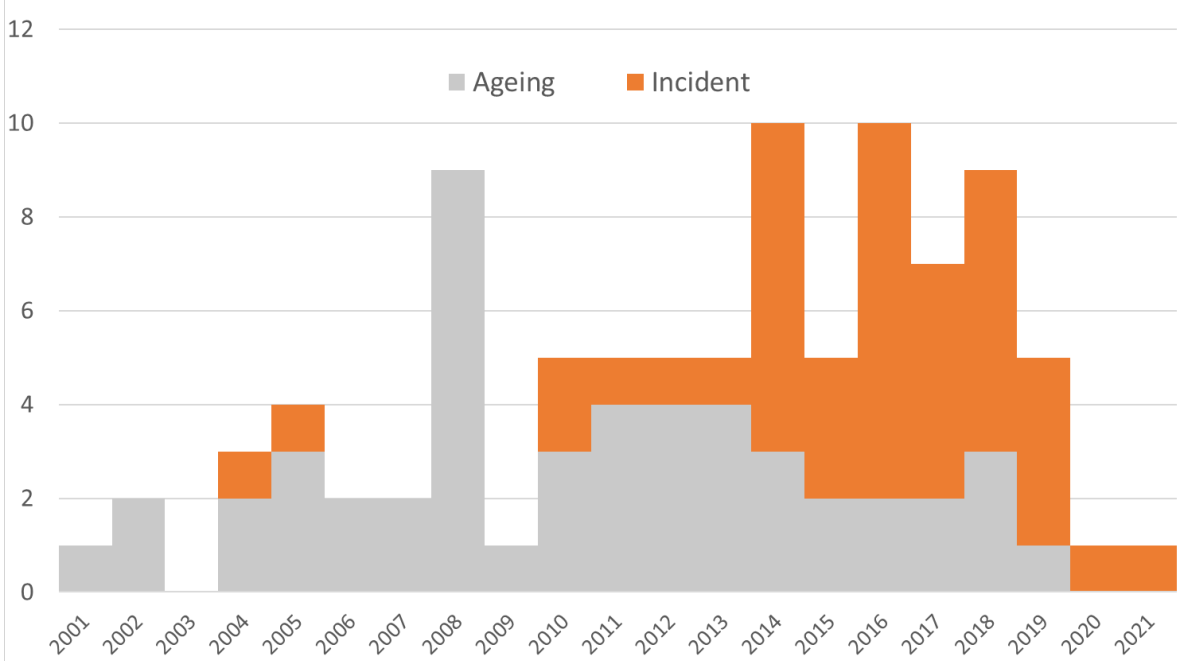
Figure 2. The machines are relatively new. Window replacements due to ageing are more common for machines >10 years while incidents predominate as the cause of replacements for machines <10 years. The five oldest machines in the material have been excluded from the graph above.

Most machines reported in the survey are relatively new. Figure 2 show the distribution of machines by year of manufacture over replacements due to ageing (disposal) and post-incident replacement respectively. (The five oldest machines in the material, 1974–1999, were excluded). The figure shows that the slightly older machines (2001–2013) dominate in terms of replacements due to ageing, while

newer machines (2014–2021) dominate reports of replacement due to incidents. On average the machines with windows replaced after an incident were 5 years old, while the machines reporting window replacement after ageing were 10 years old.

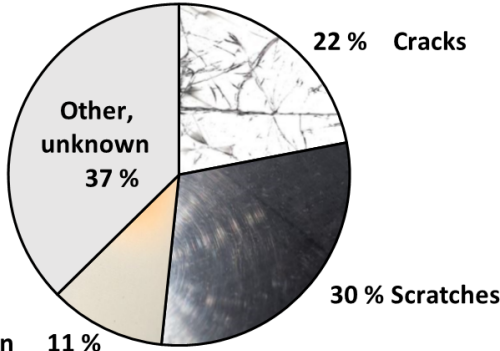
Figure 3. Causes of pane replacement after ageing. Microcracks and scratches form the basis for more than half of the cassations.

In the study, we tried to distinguish between replacements after incidents ("near accident") and replacements due to slow deterioration, over time. Sixty percent of the reports concerned replacements due to ageing, i.e. gradually deteriorating properties such as discoloration or scratches. In 37 % of cases, the cause could not be concluded (Figure 3). Replacements due to ageing are about as common for harvesters (52 %) as for forwarders (48 %).

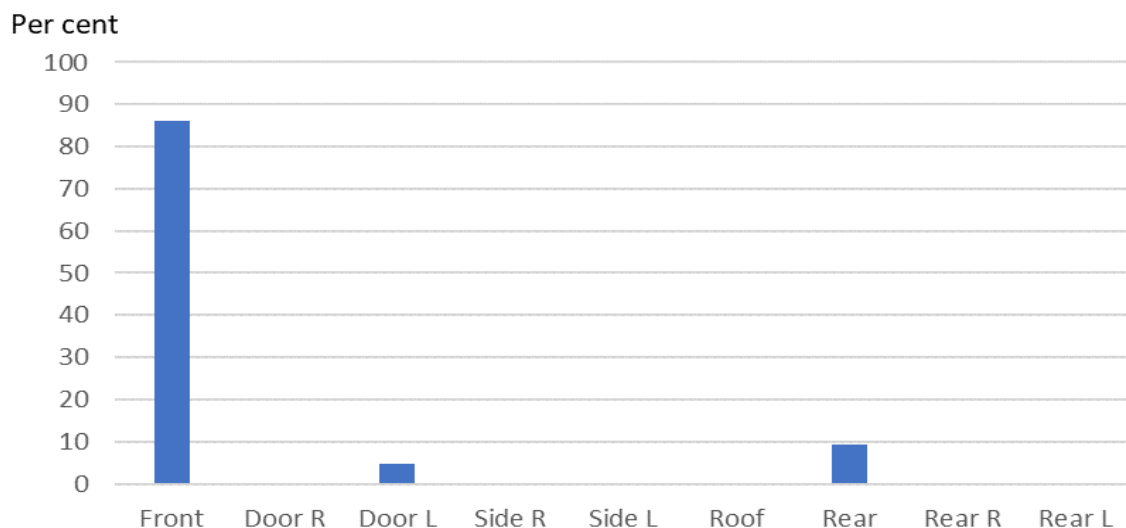
Figure 5. For harvesters, the front windowpane is most commonly damaged.

For harvesters, the front window is by far the most vulnerable to incidents. In the dataset, almost 90% of incidents affected the front window (Figure 5).

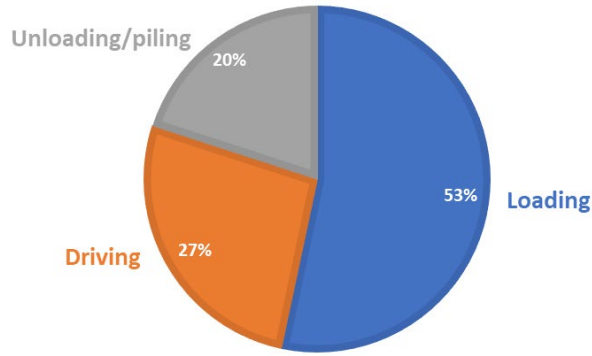
Figure 6. The distribution of incidents over different work tasks for forwarders.

Loading is the riskiest work task and accounts for over half of the incidents reported for forwarders (Figure 6). The typical incident is that logs dropped from the grapple falls or bounces against the cab. Another situation is that small trees and branches are broken and hit the pane with high force.

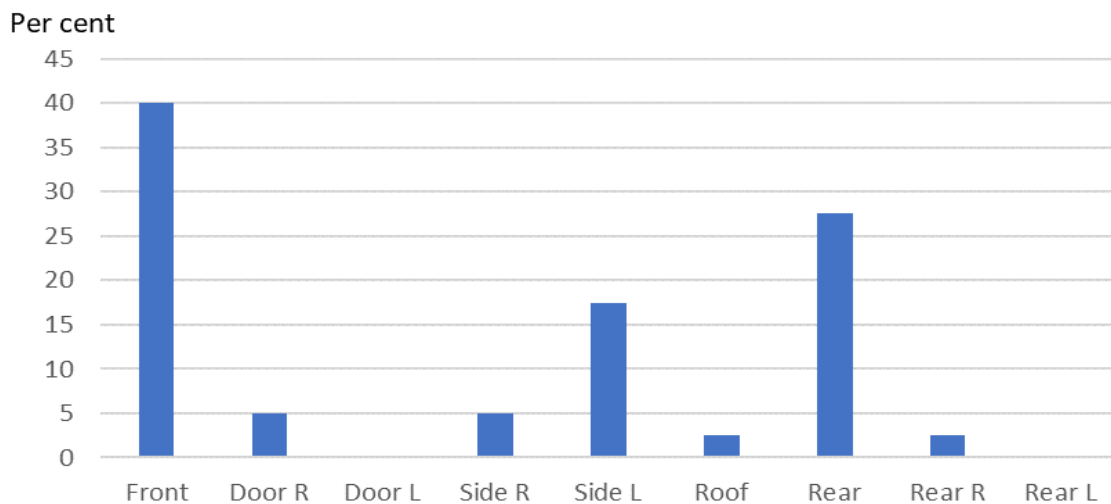
Figure 7. The front window is the most frequently damaged pane on forwarders, but incidents affecting other panes frequently occur.

Also for forwarders, it is the front window that is most commonly damaged, but rear and side windows seem more exposed to incidents than for harvesters (Figure 7).
